## Harvest Fraser Richmond Organics

### Infrastructure Update – May 2016

Date: May 12, 2016

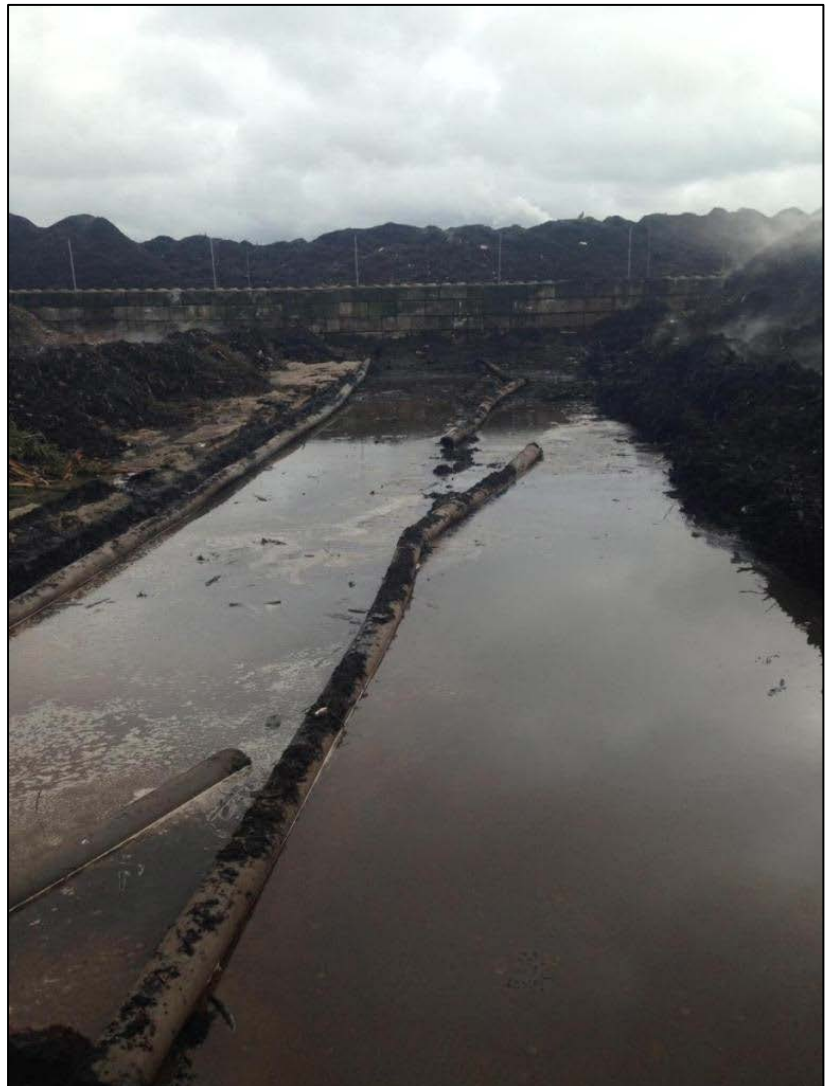
#### **BEFORE**

- In this picture, there are (at least) 3 problems: pipes are broken, clogged, and flooded. All 3 contribute to less oxygen and air flow in the piles, which leads to higher likelihood of anaerobic pockets and more odourous conditions.
- Furthermore, these problems also mean less efficiency in the collection system, i.e. less of the odourous air is captured and sent to the biofilters.
- In addition, ground saturation from heavy winter rains led to the pooling of water under the compost pile which also becomes odourous.

In these pictures, you can see how we are addressing the root causes:

- A new sand base will prevent pooling of water.
- New pipes will address the broken/clogged pipe issue.
- A more aggressive maintenance and repair program will prevent recurrence of these problems.
